**NATIONAL TRANSPORTATION SAFETY BOARD
Office of Research and Engineering
Vehicle Recorder Division
Washington, D.C. 20594**

GROUP CHAIRMAN'S FACTUAL REPORT OF INVESTIGATION

CEN15FA034

Location: Wichita, Kansas
Date: October 30, 2014
Aircraft: Hawker Beechcraft 200, Registration N52SZ
Operator: Private
NTSB Number: CEN15FA034

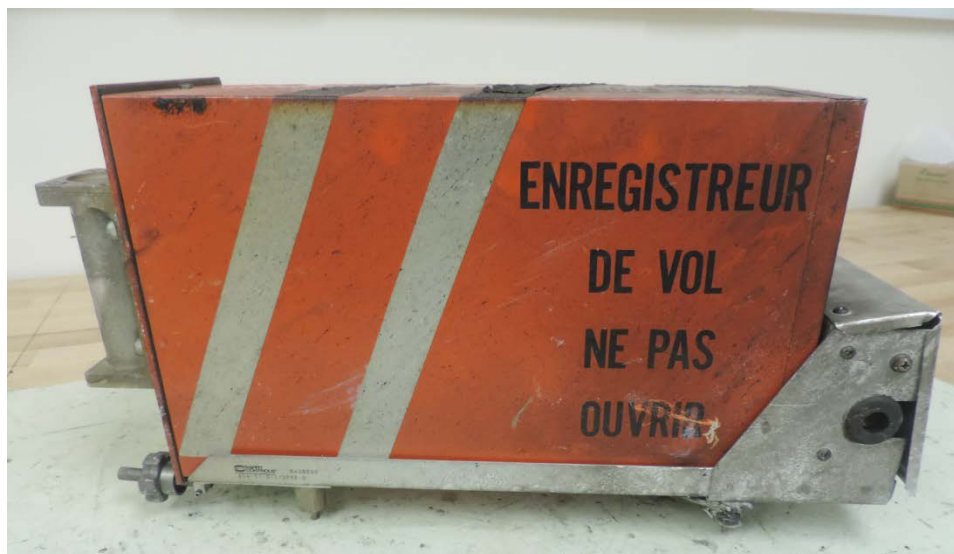
Upon arrival at the laboratory, an external inspection indicated signs of heat/smoke exposure. An internal inspection was performed, and it was evident that the CVR had not sustained any functional heat or structural damage (see figure 1). The audio information was extracted from the recorder normally, without difficulty.

Figure 1. Fairchild A-100S CVR recovered from Hawker Beechcraft 200, N52SZ.
